INDOOR AIR QUALITY ASSESSMENT

**Leicester Middle School
Gymnasium and Locker Rooms
70 Winslow Avenue
Leicester, Massachusetts**

Prepared by:
Massachusetts Department of Public Health
Bureau of Environmental Health Assessment
September, 2001

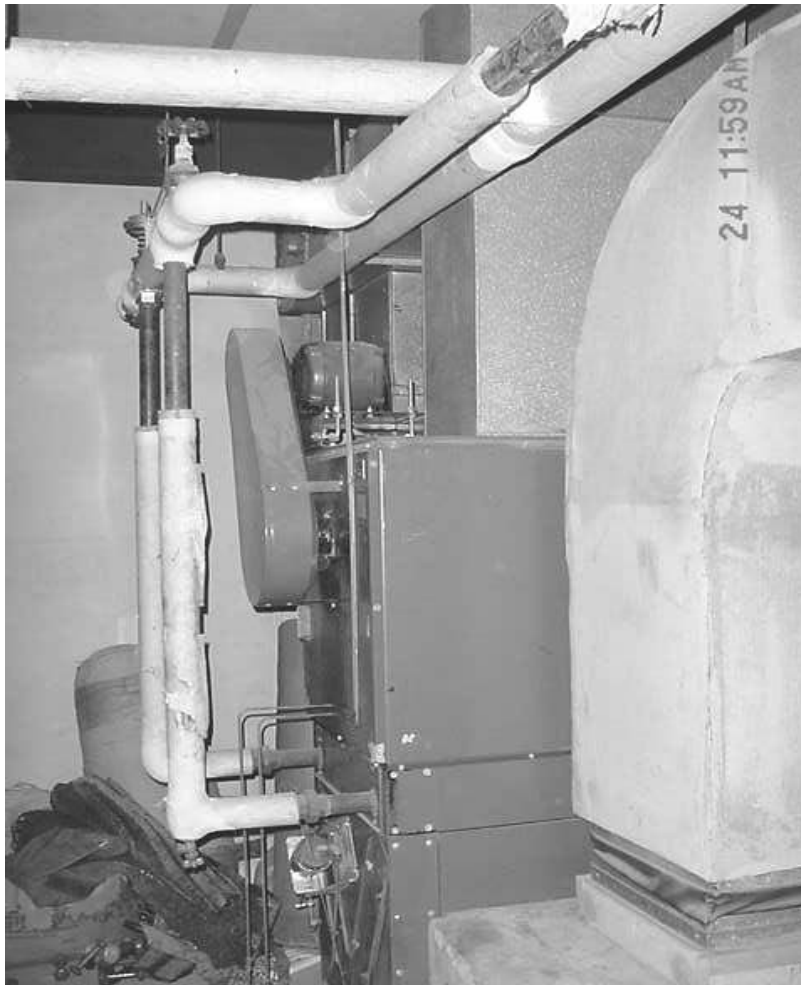
Picture 1

During the assessment, all mechanical ventilation system components were deactivated due to renovations. Fresh air in the gymnasium and locker rooms is supplied by an air-handling unit (AHU) located in a mechanical room near the gymnasium (see Picture 1). Fresh air is introduced into the unit through an air intake on the exterior of the building (see Picture 2) and distributed via wall and/or ceiling-mounted air diffusers (see Pictures 3 & 4). Exhaust ventilation is provided by wall-mounted return vents that draw air back to the AHU via ductwork. School officials stated that an HVAC consultant working for the Leicester School Department found the louvers to the return vents closed,

Gymnasium AHU Located in Mechanical Room Loft

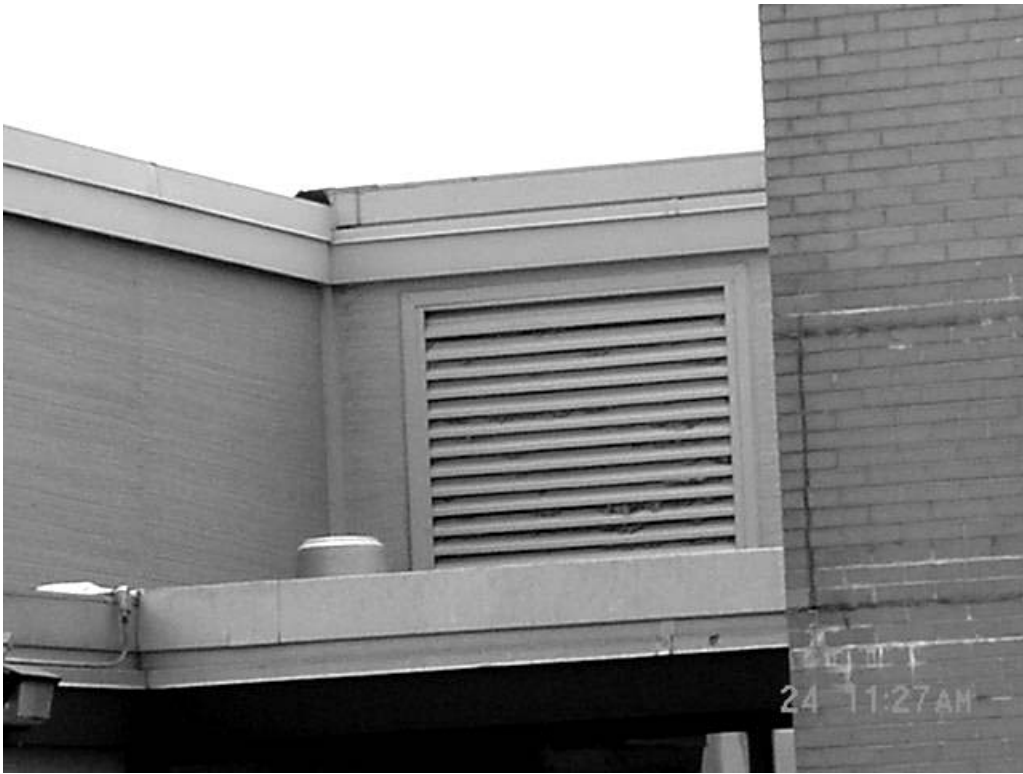
Picture 2

Fresh Air Intake for Gymnasium AHU

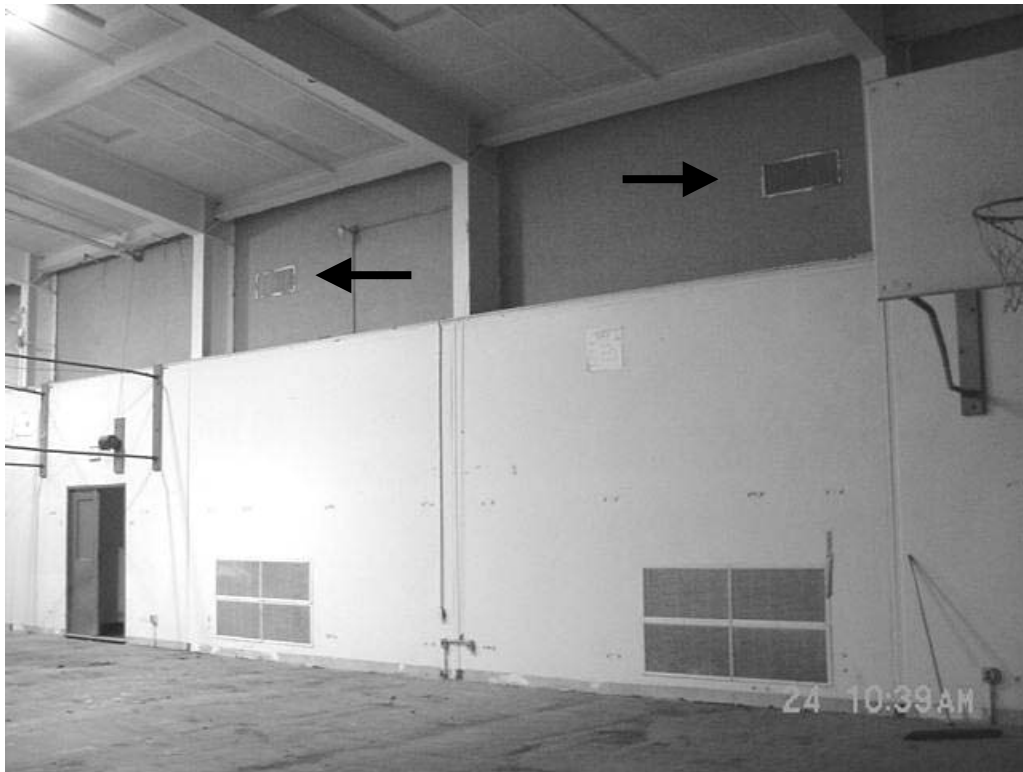
Picture 3

which would interfere with proper airflow into the vents. BEHA staff confirmed that the return louvers were closed.

Supply (indicated by arrows) and Return Vents (along wall near floor) in Gym

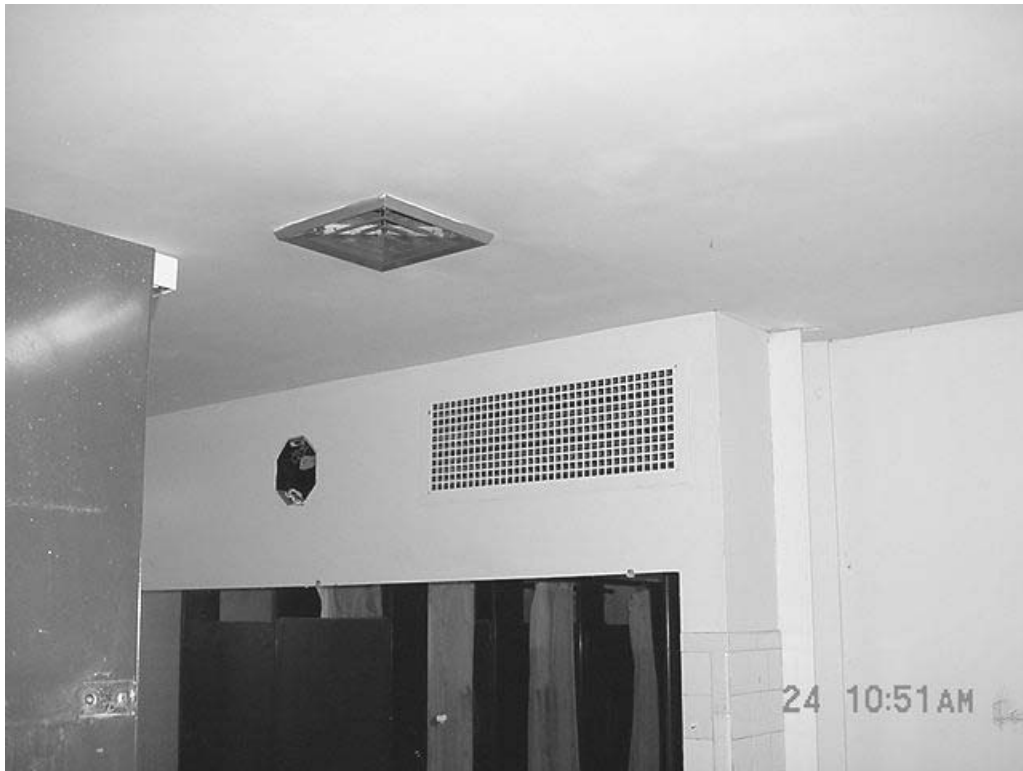
Picture 4

Supply Vents for Locker Room(s)

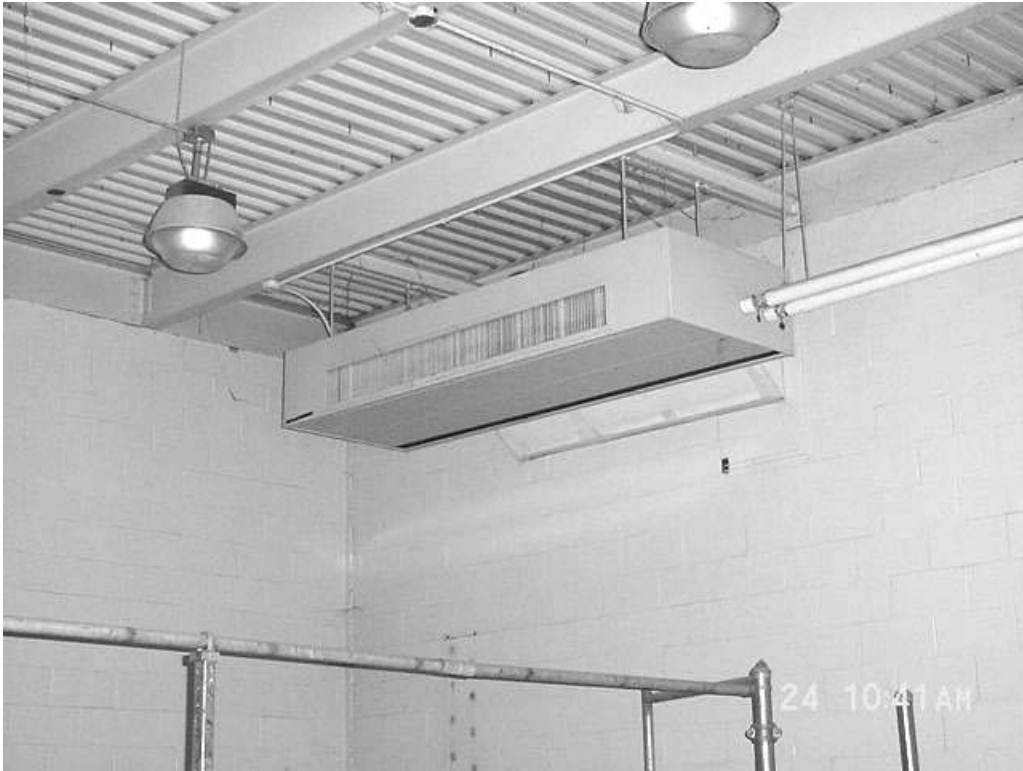
Picture 5

Fresh air in the weight room is supplied by two ceiling-mounted unit ventilators (univents) (see Picture 5). Univents draw air from outdoors through a fresh air intake located on the exterior walls of a building (see Picture 6) and return air to the unit through an air intake located at the base of each unit. The mixture of fresh and return air is drawn through a filter and a heating coil, and is then expelled from the univent by motorized fans through fresh air diffusers (see [Figure 1](#)). As with the AHU, this system was not operating during the assessment. Exhaust ventilation for the weight room and locker rooms is provided by wall/ceiling-mounted grilles connected to rooftop motors via ductwork (see Pictures 7 & 8).

Wall-Mounted Univent in Weight Room off Gym

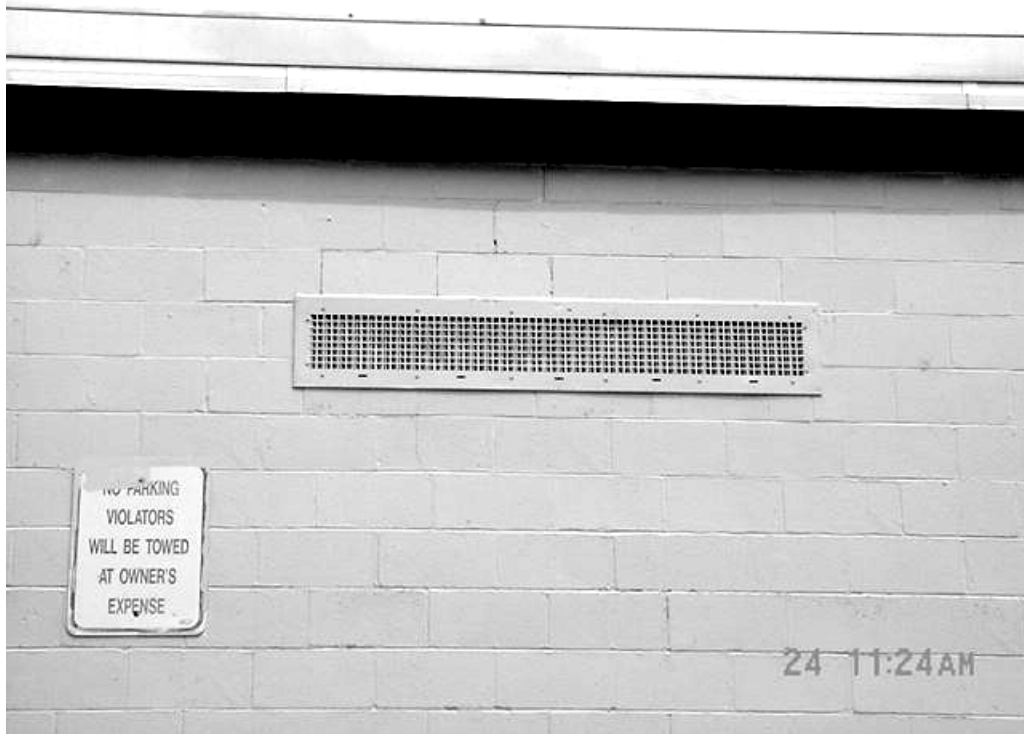
Picture 6

Outside Air Intake for Weight Room Univent

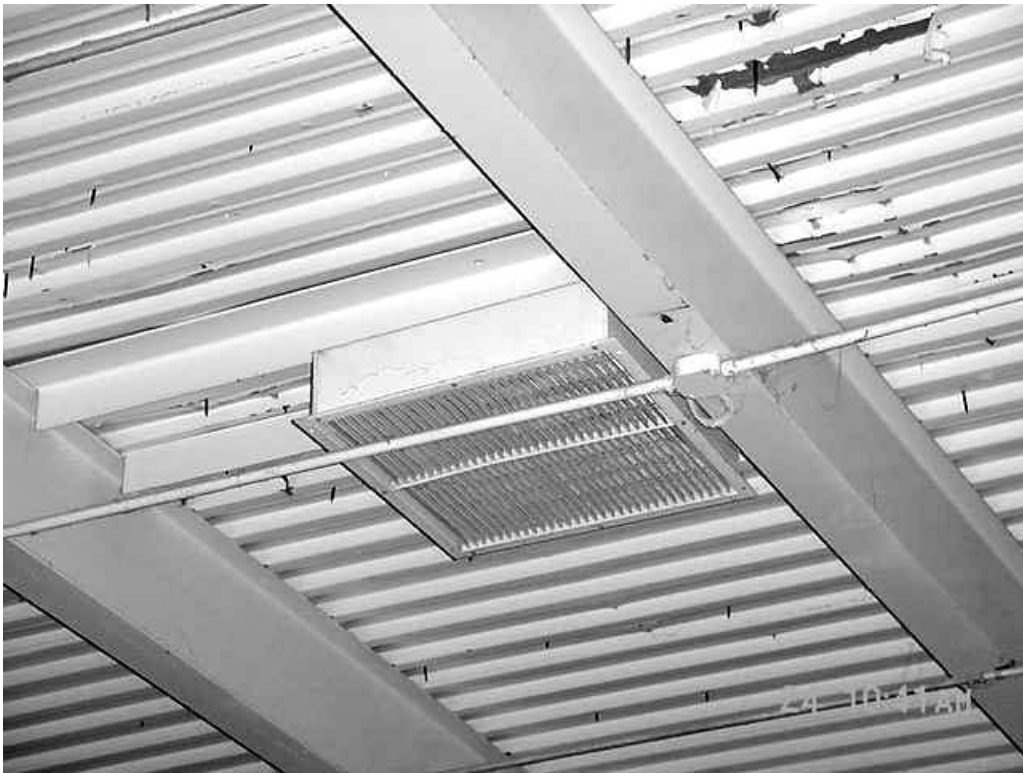
Picture 7

Ceiling-Mounted Exhaust Vent in Weight Room

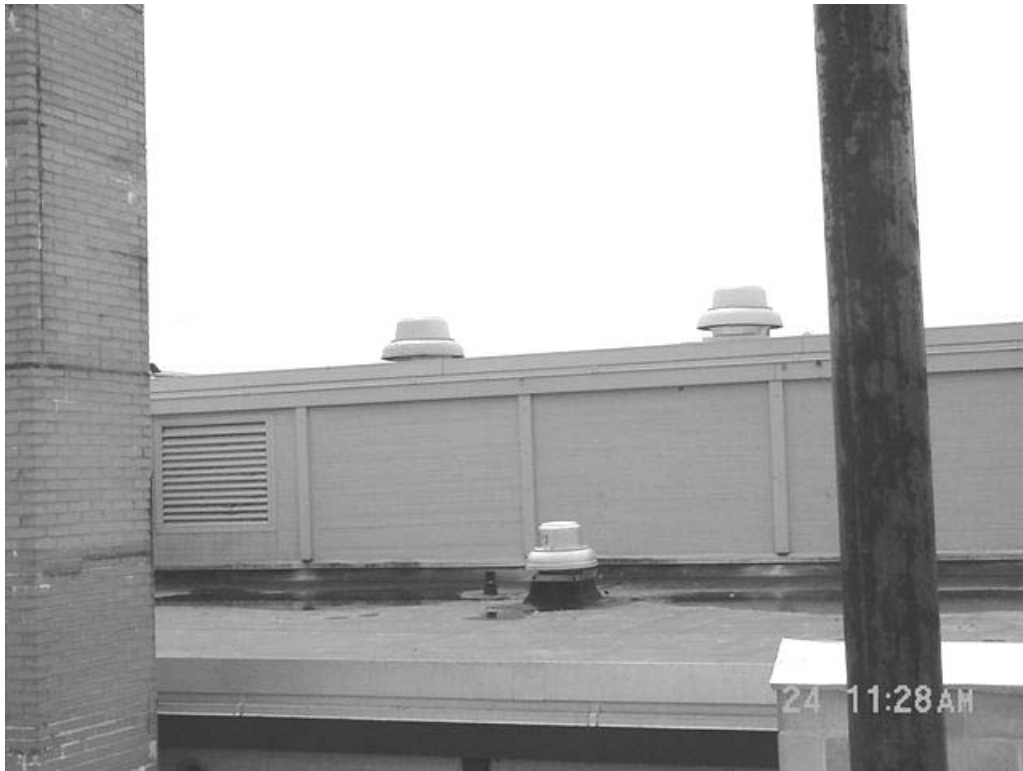
Picture 8

Rooftop Exhaust Motors

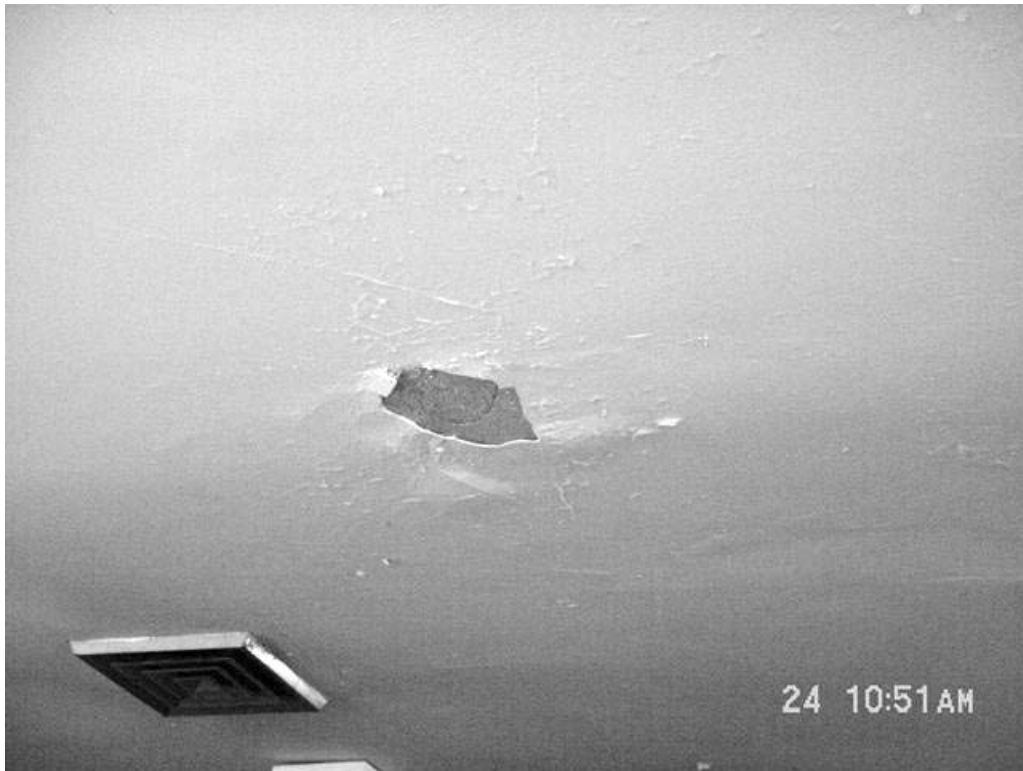
Picture 9

As mentioned previously, the assessment occurred after three days of rain. No active water leaks were reported or observed in the gymnasium or girl's locker rooms and no active mold growth was observed. Evidence of historic water damage was noted on ceiling plaster. Water intrusion was evident by the presence of efflorescence (e.g., mineral deposits) and peeling paint (see Pictures 9 & 10). Efflorescence is a characteristic sign of water damage to brick and mortar, but it is not mold growth. As moisture penetrates and works its way through mortar around brick, water-soluble compounds in bricks and mortar dissolve, creating a solution. As the solution moves to the surface of the brick or mortar, water evaporates, leaving behind white, powdery mineral deposits. Wall/ceiling plaster is not a good mold growth media, however water trapped behind wallpaper or paint coats can become mold growth media. These materials should be replaced/repared after a water leak is discovered.

Peeling Paint on Ceiling of Girl's Locker Room

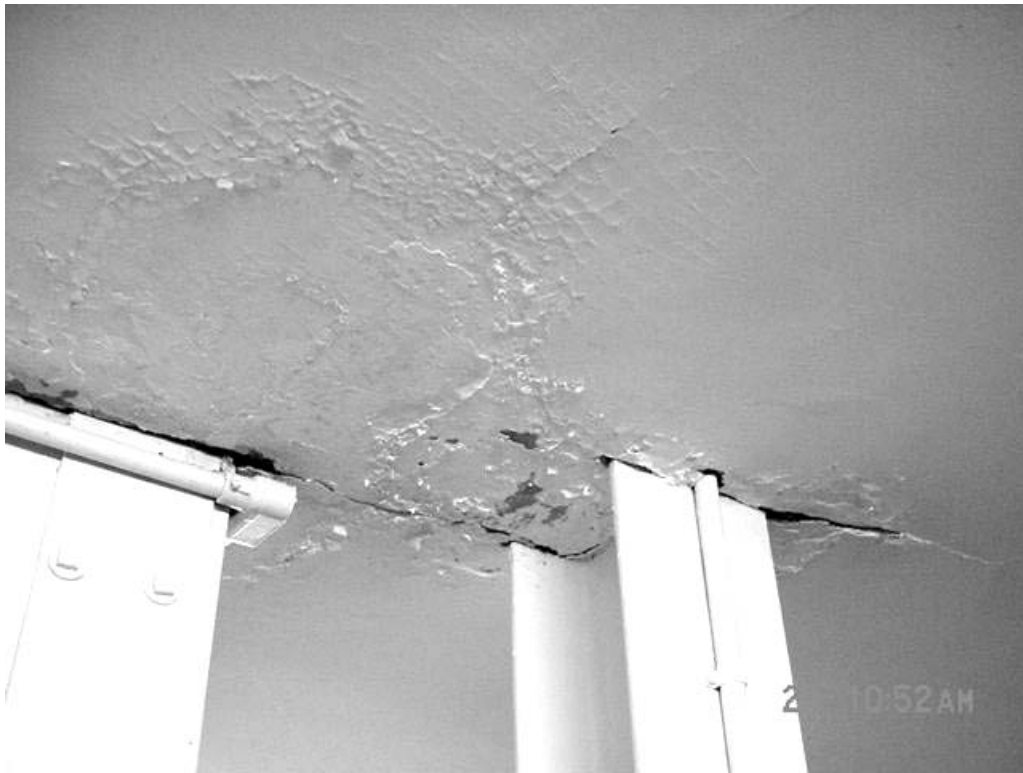
Picture 10

Water Damaged Ceiling Plaster & Efflorescence on Girl's Locker Room

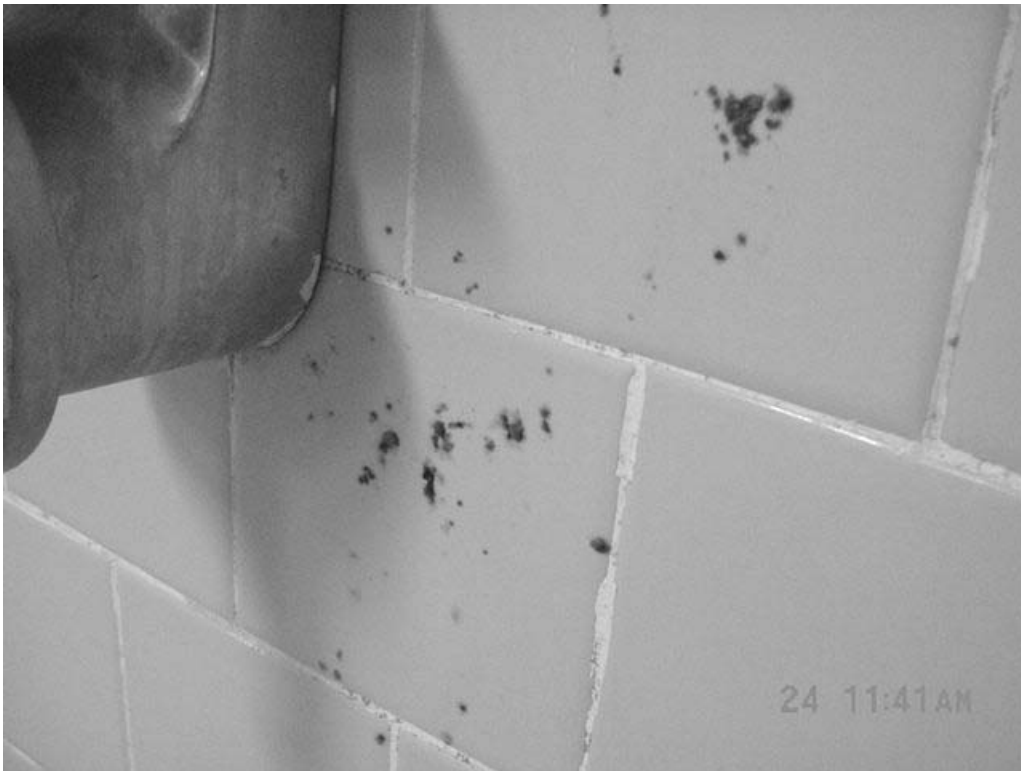
Picture 11

Active mold growth was observed in the boy's locker room on the ceiling and on shower tiles (see Pictures 11 & 12). The mold appeared to be common mold growth associated with moisture accumulation/high relative humidity due to shower usage rather than due to chronic water damage from plumbing and/or outdoor leaks.

Mold Growth (black spots) on Shower Tiles in Boy's Locker Room

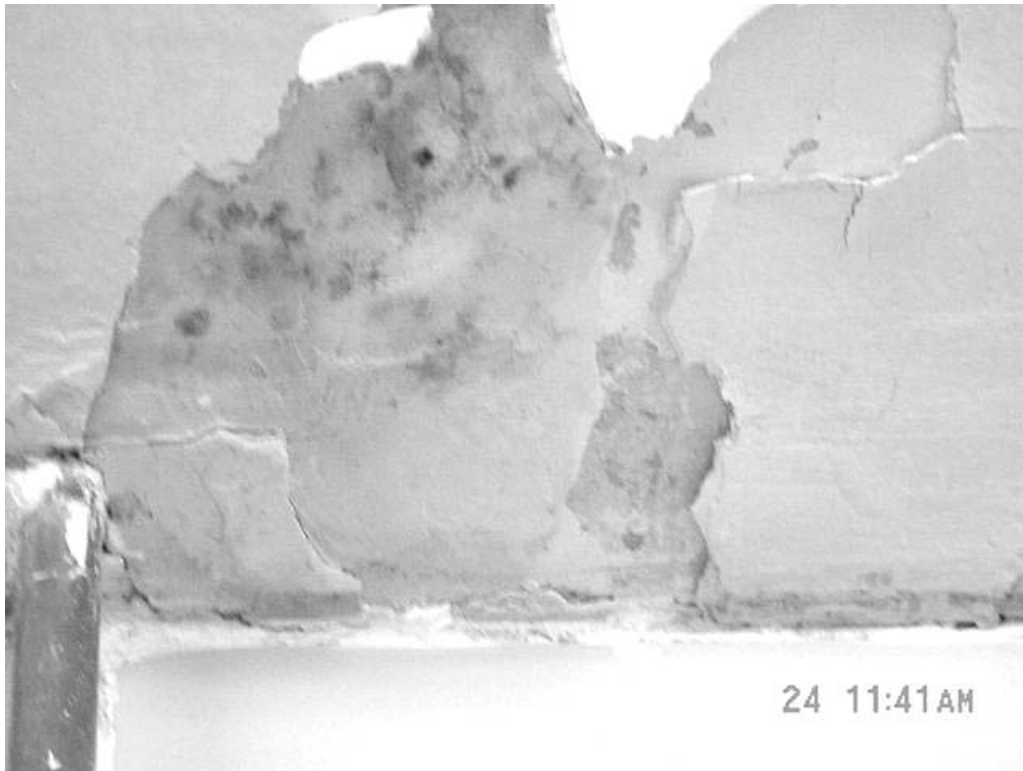
Picture 12

Mold Growth (black spots) on Ceiling in Shower Area of Boy's Locker Room

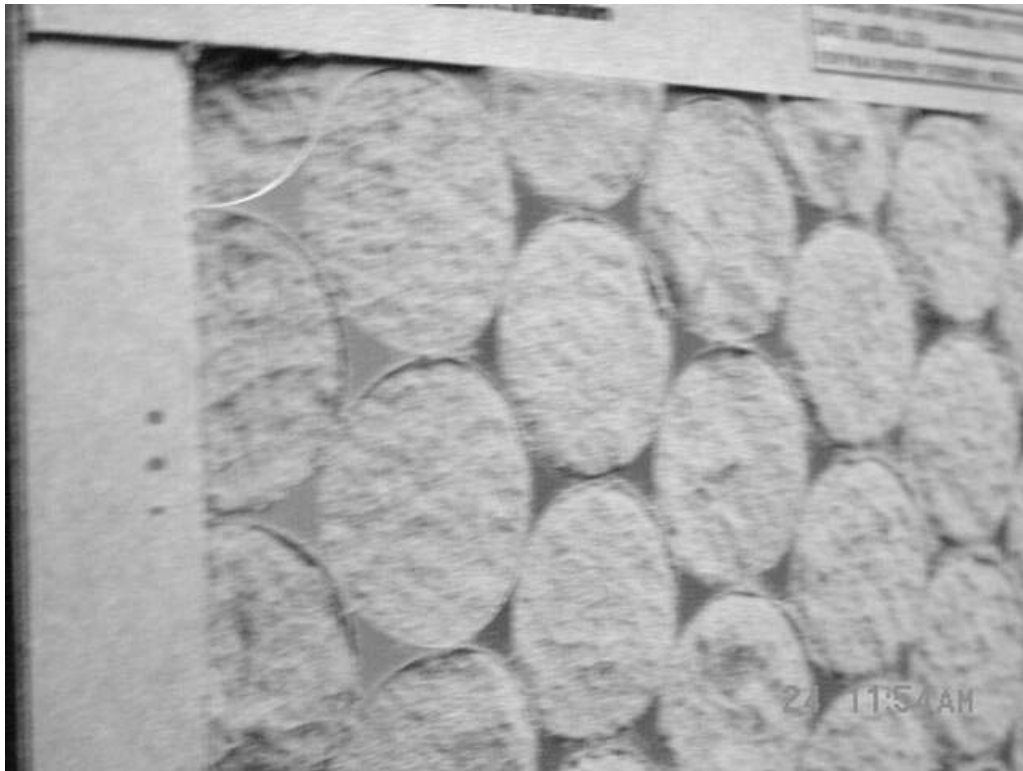
Picture 13

Several conditions that can potentially affect indoor air quality were also identified. BEHA staff examined the gymnasium AHU and found the filter coated with dirt/dust and accumulated material (see Picture 13). A debris-saturated filter can obstruct airflow, damage equipment and may serve as a reservoir of particulates that can be re-aerosolized and distributed into occupied areas via the ventilation system.

Gymnasium AHU Air Filter Occluded With Dust & Debris

1. Once renovations are complete, operate mechanical ventilation in the gymnasium and locker rooms during hours of school occupation.
2. Inspect mechanical ventilation components regularly for proper function. Repair and replace motors and belts as necessary.
3. Remove all blockages from supply and exhaust vents. Inspect periodically to ensure these areas remain free from obstructions.
4. Consider having the ventilation system balanced by an HVAC engineering firm.
5. Disinfect areas with active mold growth with an appropriate antimicrobial.
6. Repair water damaged plaster/peeling paint.
7. Change/clean filters in univents and AHUs as per the manufacturer's instructions (or more frequently if needed) to prevent the re-aerosolization of dirt, dust and particulate matter.
